## Ice Jam Loosens Up, Fragments Travel Downstream

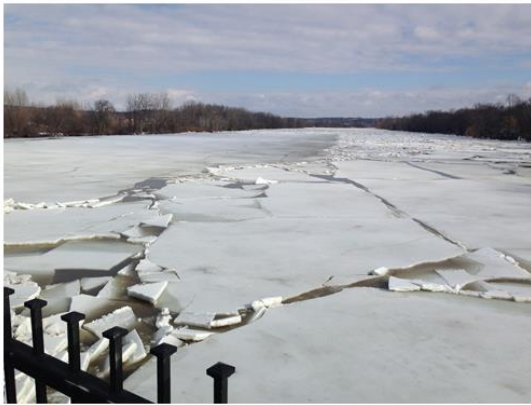
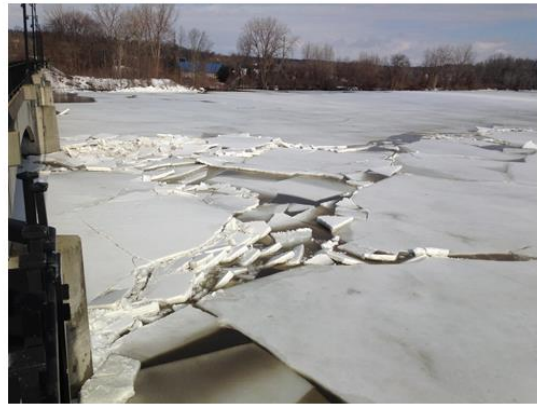
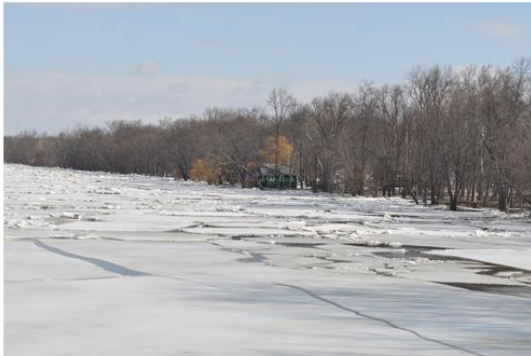
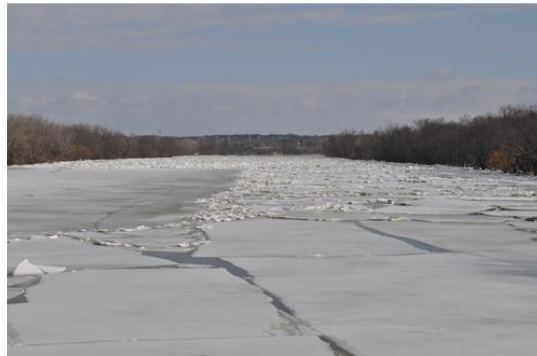
## Pictures from North Park Street Bridge

Large sheets and chunks of ice that created rapid rises on the Grand River this morning are on the move. Ice began building on the North Park Street Bridge (north of downtown Grand Rapids), causing rapid and frequent fluctuations around Comstock Park. River levels went from 11.7 feet at around 7:40 a.m., to 12.5 feet around 9:30 a.m. The peak level was recorded at 12.8 feet around 11:22 a.m. River levels at Comstock Park fluctuated between 12.4 feet and 12.8 feet through the event. Finally, ice began to break around noon, the same time in which observations showed a steep drop. Comstock Park fell to 12.1 feet at 12:30 p.m. and eventually fell to 11.65 feet by 2:00 p.m.

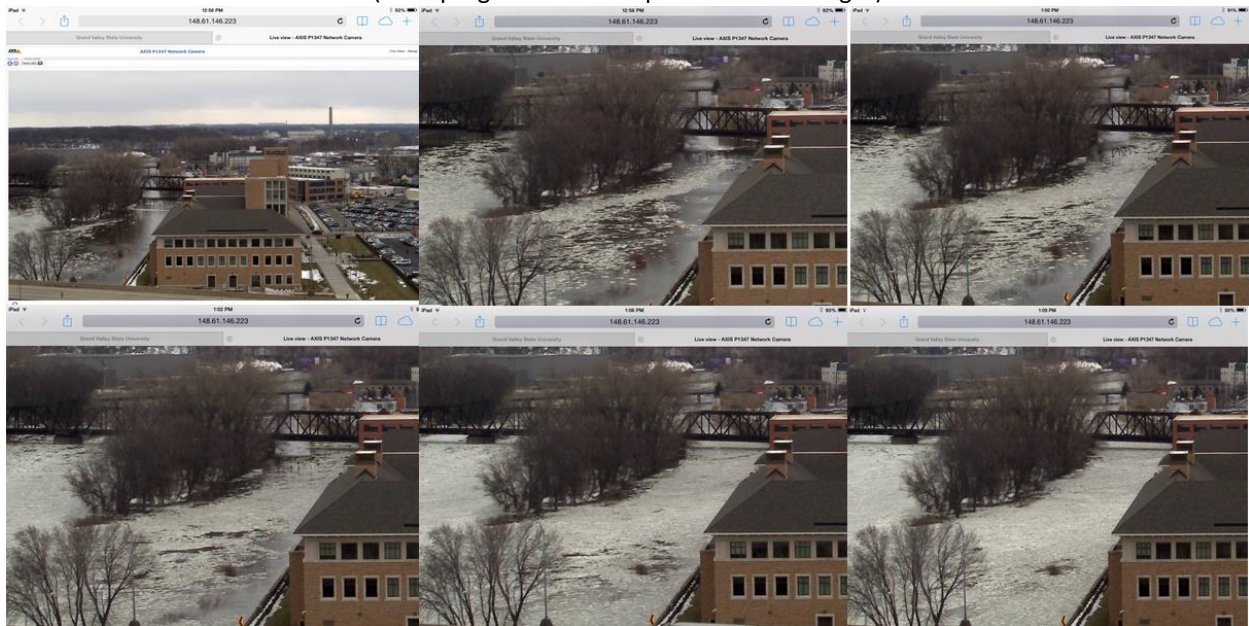
## Pictures near the Fulton Street Bridge

(Time progresses from top left to bottom right)
